Subject: Westside Water Association, ID# 94950
King County
Routine Sanitary Survey 2018

ROUTINE SANITARY SURVEY REPORT

WESTSIDE WATER ASSOCIATION

ID # 94950, King County

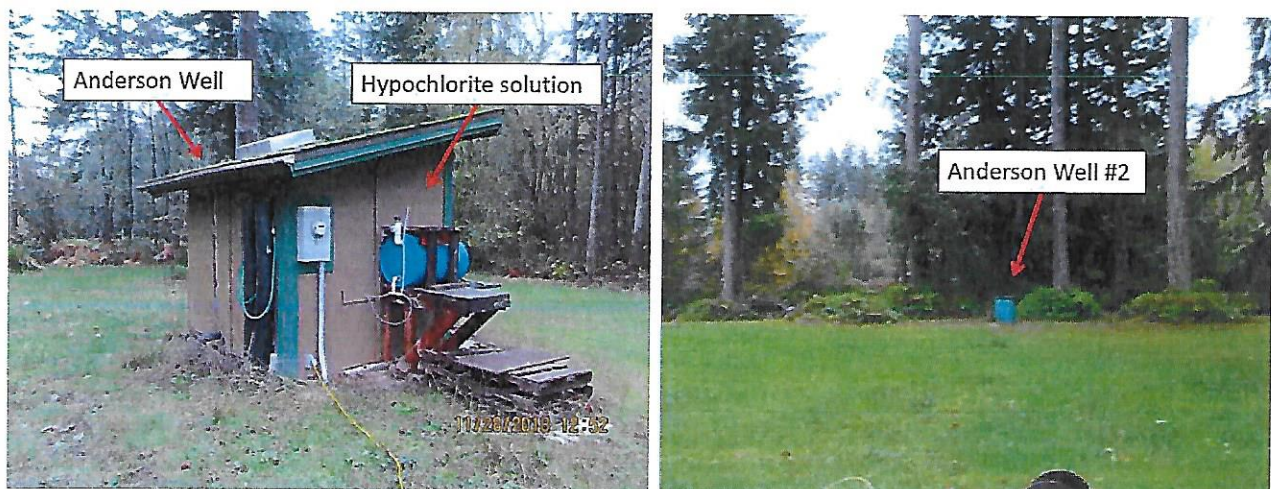
Figure 1. (Left) Anderson Well wellhouse and hypochlorite solution. Think about adding a lock to the door. (Right) View of Anderson Well#2 from the Anderson Well (S07) wellhouse. No potentially hazardous contaminants in the sanitary control area.

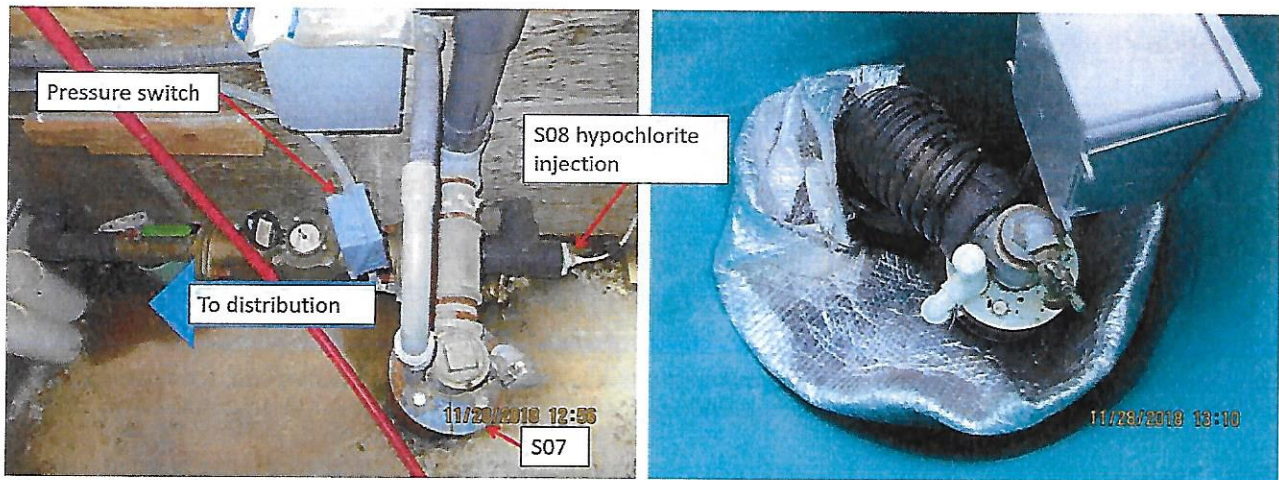
Figure 2. (Left) Anderson Well (S07) wellhead has good seals and screens, and a sample tap. Anderson Well #2 (S08) and meter shown here entering the building behind S07. (Right) Anderson Well #2 (S08) wellhead has good seals and screens, and a sample tap. The enclosure is tightly sealed and effective at keeping critters out. It is not clear how air gets in the enclosure.

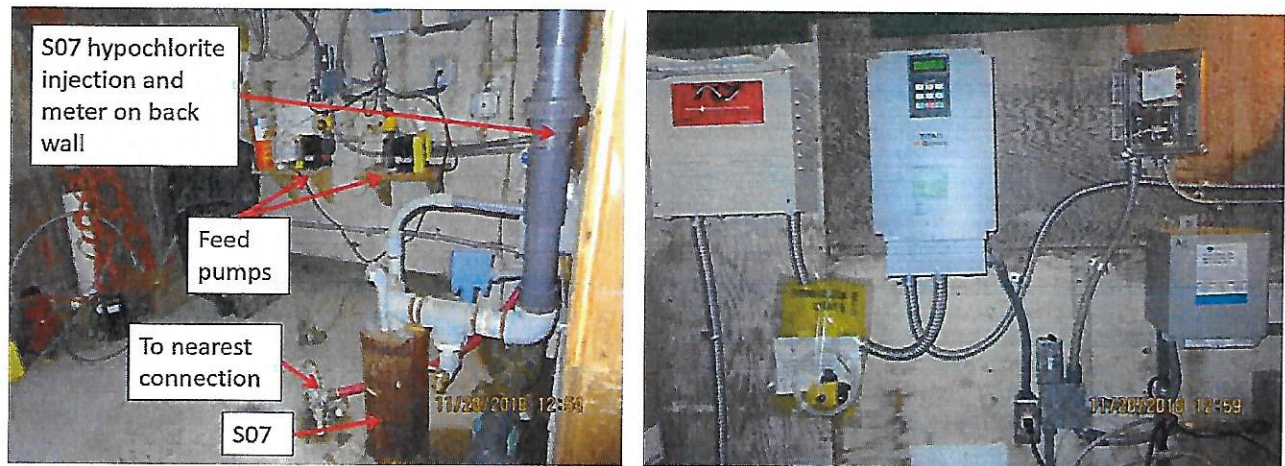
Figure 3. (Left) S07 hypochlorite injection and meter is on the back wall. (Right) Controls for Anderson Wells. Upper right shows the Herrin controller.

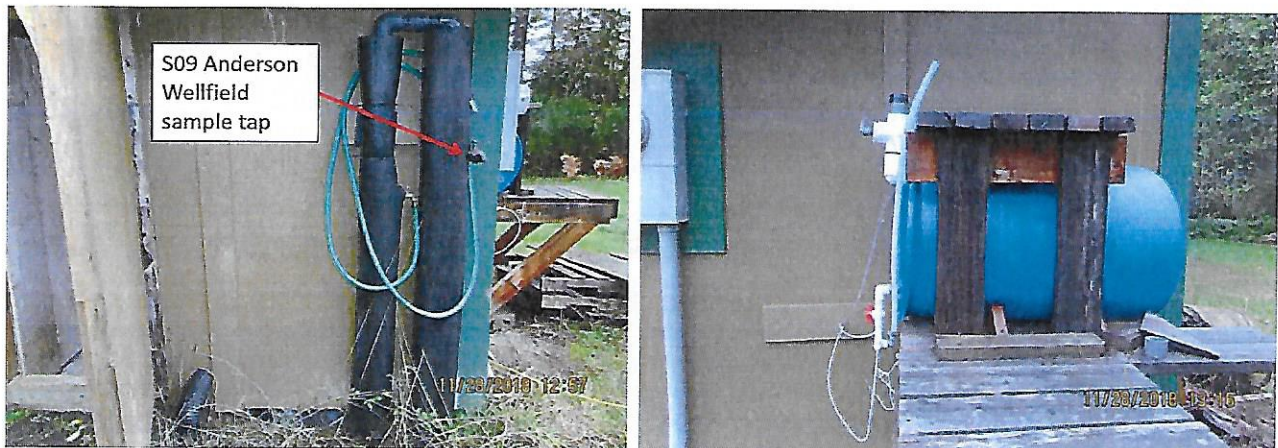
Figure 4. (Left) Anderson Wellfield sample tap. (Right) 30-gallon sodium hypochlorite solution.

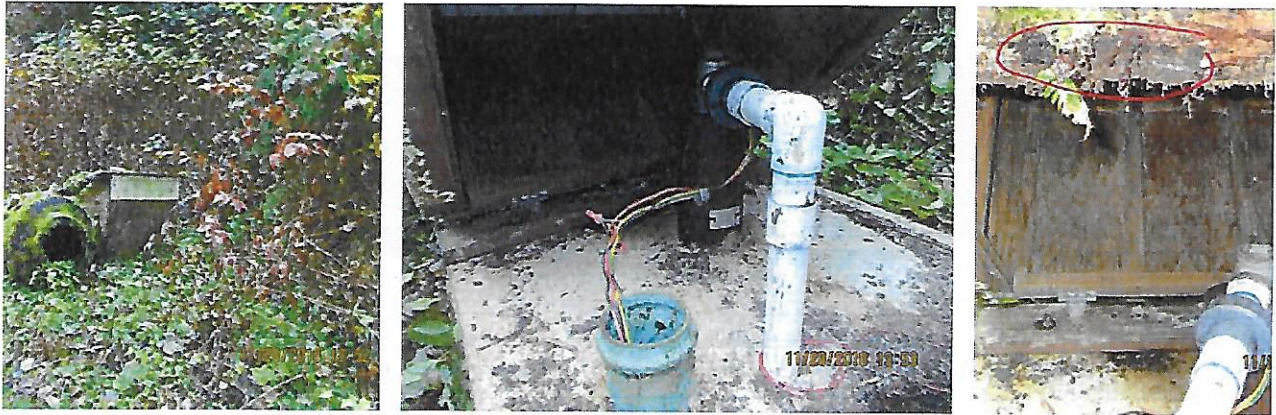
Figure 5. Canyon Well. Source meter and sample tap (not shown here) are located behind the Canyon pump house. (Left) Wellhead enclosure. (Center) Good seals and screens. (Right) Wellhead enclosure front bottom board has rotted and could be replaced.

6. The approved ATEC filtration treatment system for arsenic removal is not in use. Continue to consider arsenic removal treatment of the Canyon Well (S06) as a way to increase source capacity.

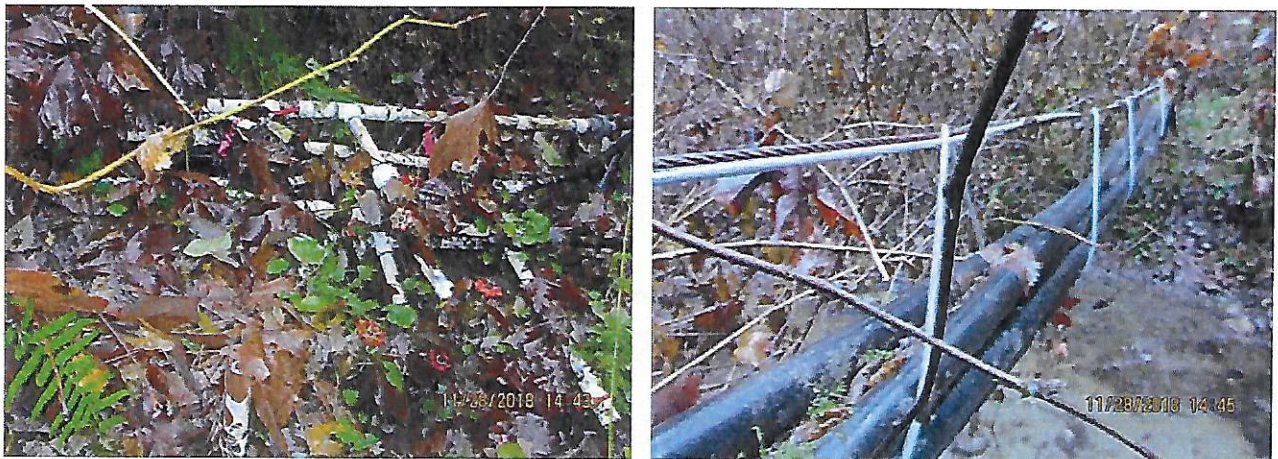
Figure 6. Wellpoints (Left) Charging station. Tap plumbed to the charging station is used to siphon the wellpoint lines as needed. (Right) Wellpoint transmission lines.

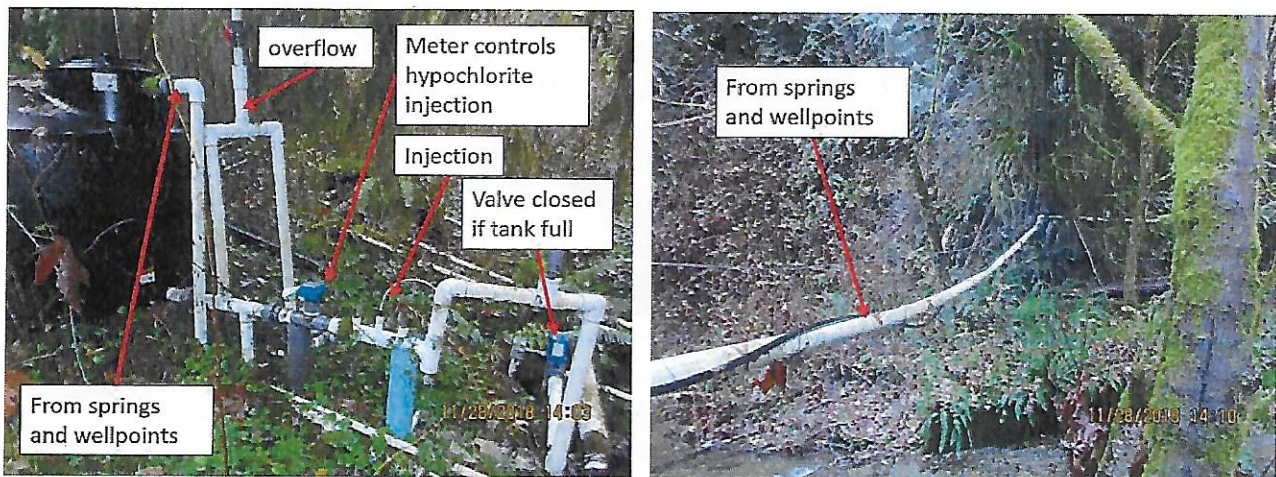
Figure 7. (Left) Springs and wellpoints flow through the 1,100-gallon black collection chamber. The overflow and surge protection piping are screened with air gap. Hypochlorite injection is after the overflow and before entering the 15,000-gallon fiberglass holding tank below the Canyon pump house. (Right) Water from the springs and wellpoints comes through the woods and across the river through PVC.

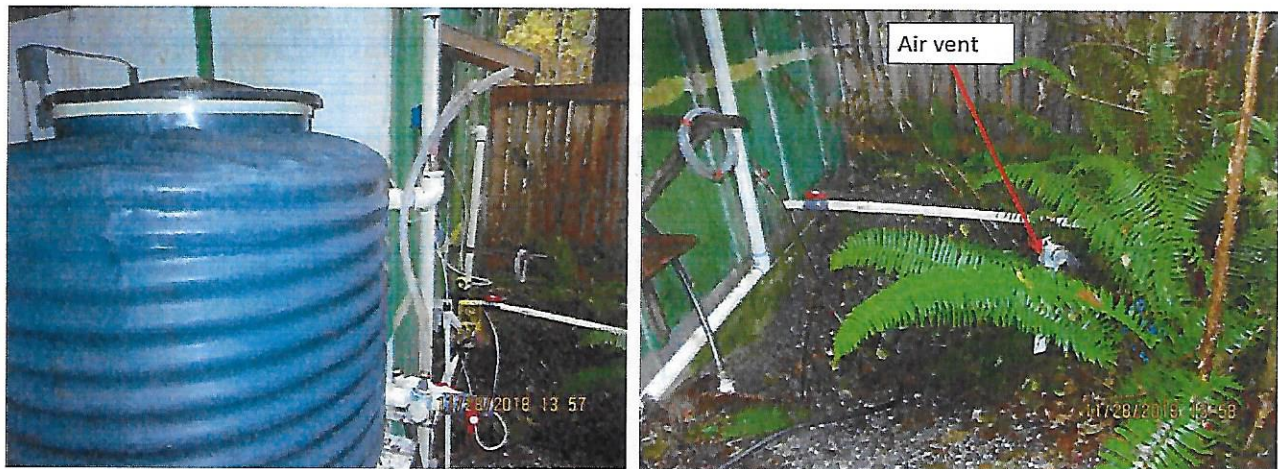
Figure 8. (Left) Blue hypochlorite solution tank. LMI feed pump for the springs and wellpoints on the exterior wall of the Canyon pump house. (Right) Screened air vent for 15,000-gallon holding tank below the Canyon pump house. Treated water is pumped from the holding tank to the Green tank.

8. Please provide a better insect barrier on the hypochlorite solution tanks. I observed upward facing air vents. The air vents should be downward facing and covered with 24-mesh non-corrodible screen.

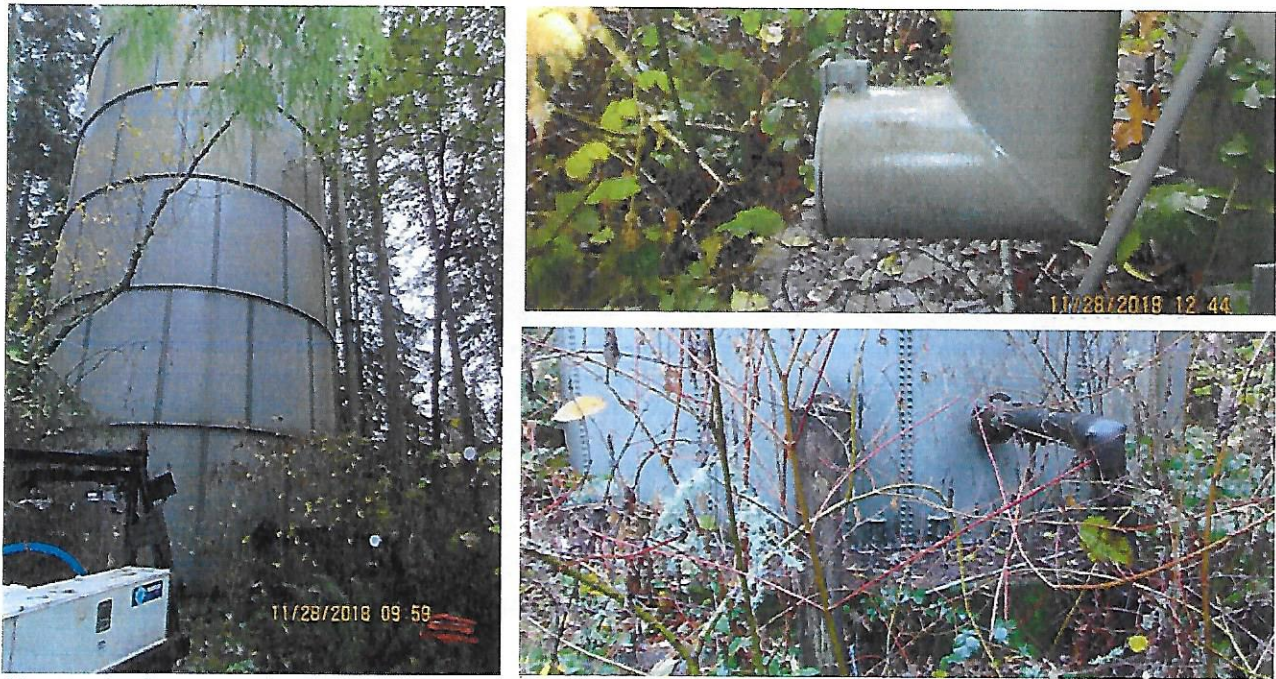
Figure 9. Green tank. (Left) Overview. Drain line daylights at roadside. (Right Upper) Exterior overflow with air gap and flapper valve. (Right Lower) Two inlets. Possible remnant of previous operation of the Green tank and Cove tank in parallel rather than series.

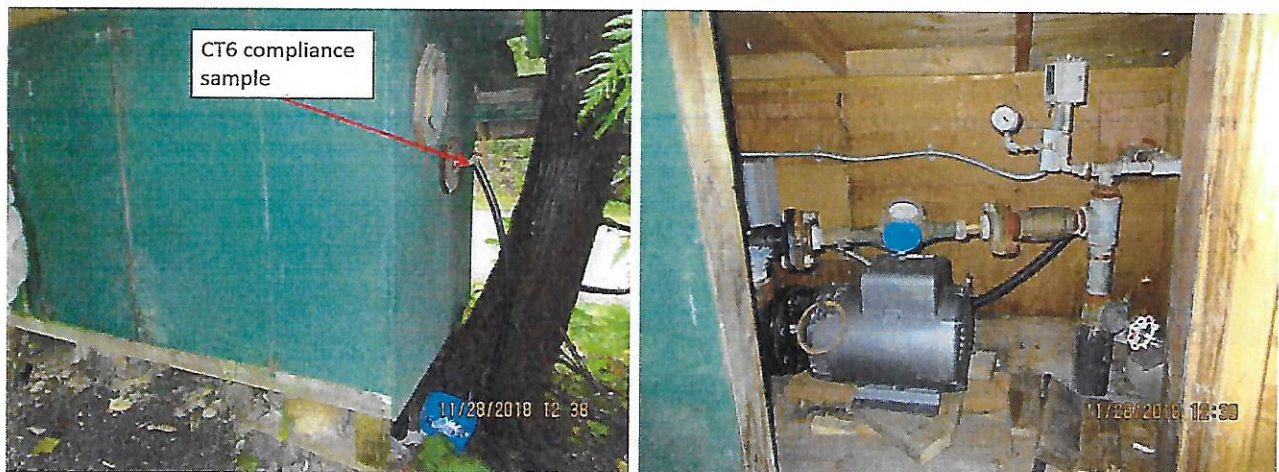
Figure 10. 156th Street BPS. (Left) Exterior view showing the entry point to distribution sample tap. (Right) Interior view.

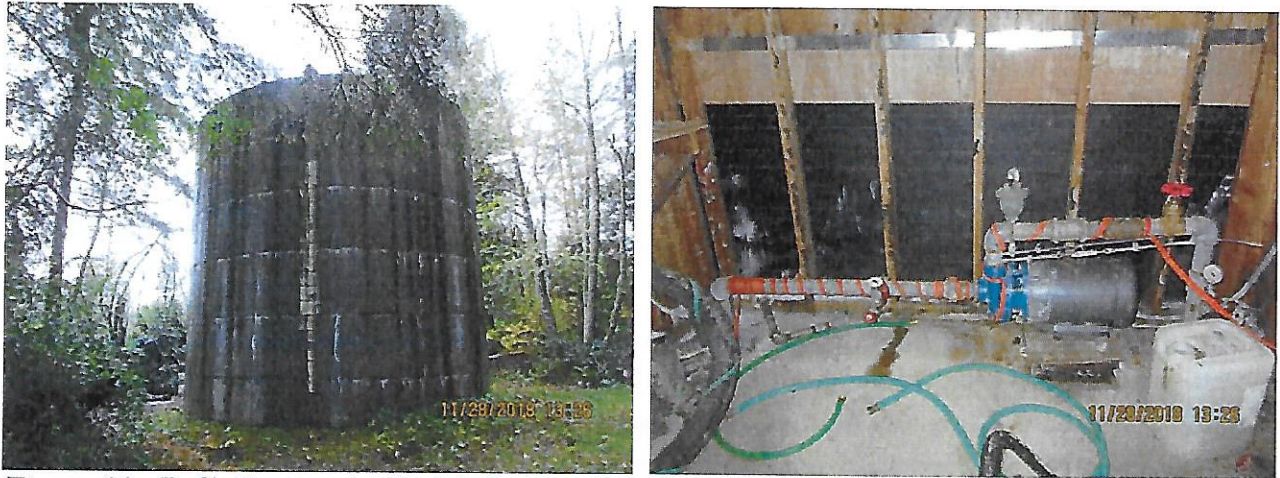
Figure 11. (Left) Cove tank. (Right) Cove tank PS. 65-psi discharge pressure. Please add a 24-mesh screen to the air-vacuum valve vent.

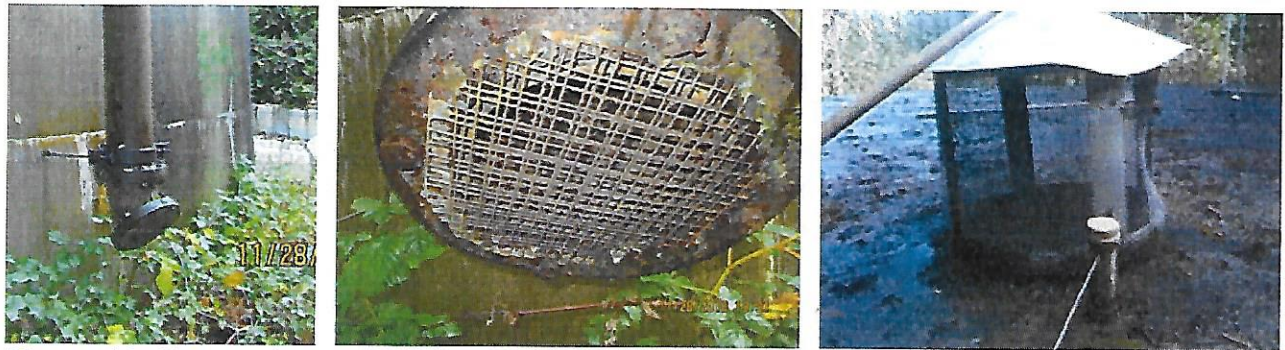
Figure 12. Cove tank. (Left) Overflow airgap. Drain line daylights at roadside. (Center) Overflow screen. Not an adequate insect barrier. (Right) Air vent. Vulnerable to surface splatter and windblown contaminants (photo provided in 2013).

1. Seals and screens must protect finished water from potential contamination. For the 100,000-gallon concrete storage tank, please plan to replace or retrofit the air vent with a design to protect against surface splatter and windblown contaminants. In addition, please add 24-mesh non-corrodible screen, tideflex, or flapper type valve on the overflow to provide a better insect barrier.
