Subject: Westside Water Association, ID #94950
King County
2023 Sanitary Survey

ROUTINE SANITARY SURVEY REPORT

WESTSIDE WATER ASSOCIATION

ID # 94950, King County

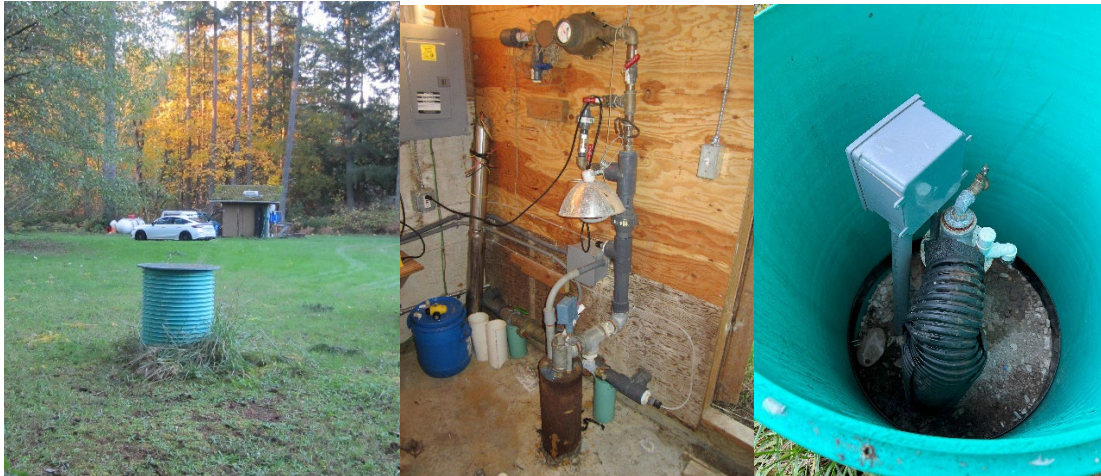
The Association has developed the Anderson Wellfield (S09) as their primary production wells (Figure 1). The Anderson Wellfield is comprised of two wells.

Figure 1. (Left) View of Anderson Well wellhouse and Anderson Well #2. Figure 2. (Middle) Anderson Well (S07). Figure 3. (Right) Anderson Well #2 (S08). No potentially hazardous contaminants in the sanitary control area.

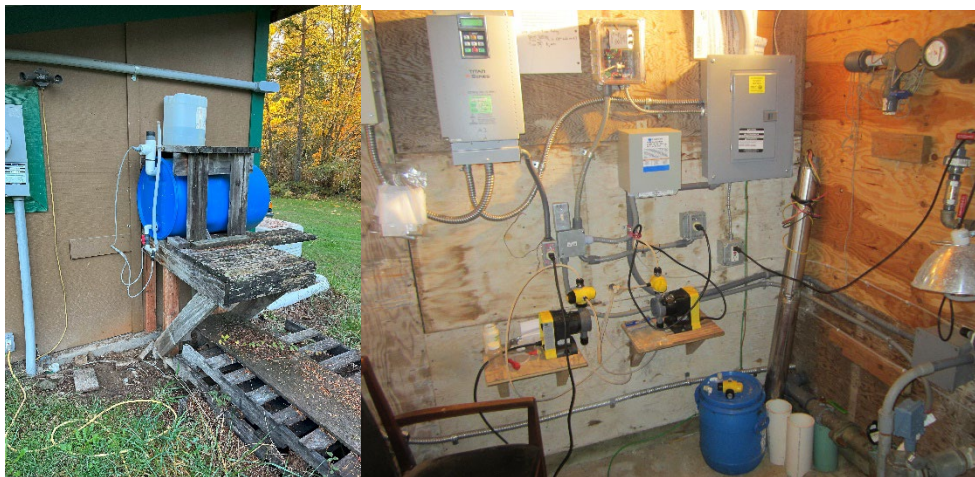
The Herrin controller and pressure switch control the well pumps (Figure 5).

Hypochlorite disinfection provided on site to maintain a constant free chlorine residual in the distribution system. A single 30-gallon tote (4:1 solution of 12.5% sodium hypochlorite) and two LMI feed pumps provide treatment for Anderson Well and Anderson Well #2 (Figures 4-5).

Figure 4. (Left) Hypochlorite Solution set up outside Anderson Wellhouse. Figure 5. (Right) Controls for Anderson Wells.

8. Please provide a better insect barrier on the hypochlorite solution tanks. I observed upward facing air vents. The air vents should be downward facing and covered with 24-mesh non-corrodible screen.

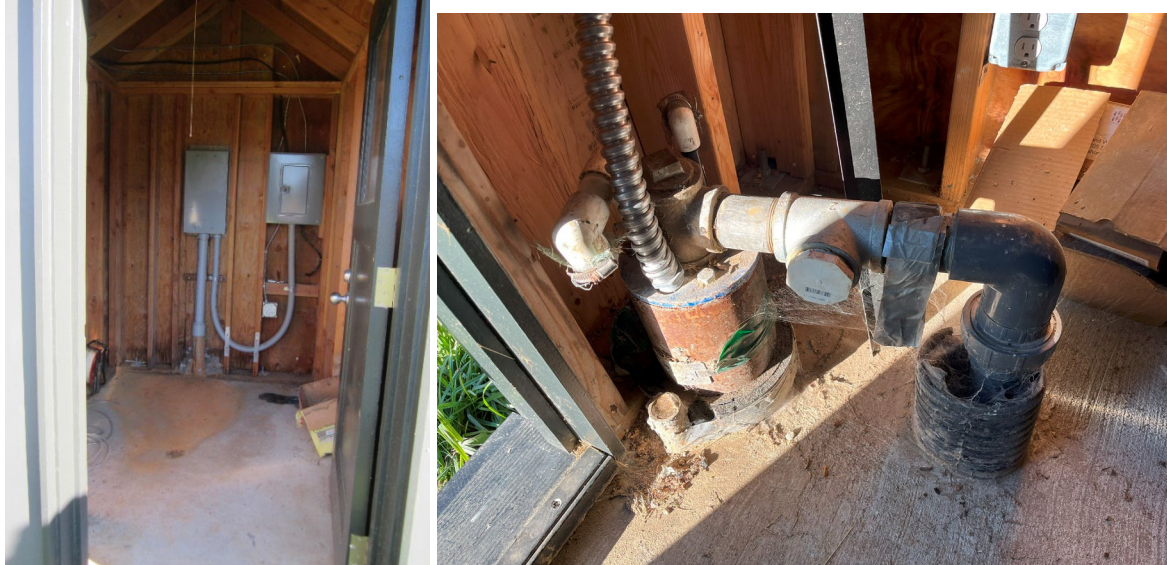
Back40 (S10) is housed in a pumphouse that sits in a privately owned field. No contaminants were observed in the sanitary control area. Currently there is no treatment connected to Back40 (S10).

Figure 6. (Left) Well Back40 (S10) pumphouse and controls. Figure 7. (Right) Well Back40 (S10).

1. Disinfection of Back40 well is required. Please send verification that treatment has been connected or provide a schedule for installation.
2. It appears that Cove Tank has had unauthorized access, which poses a risk to your drinking water. Please submit a corrective action plan for restricting unauthorized access.

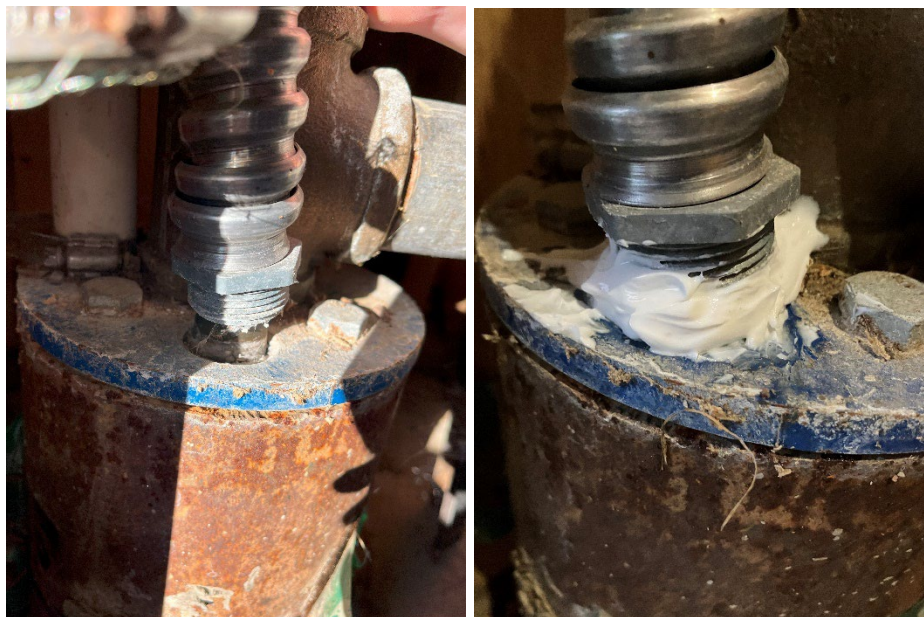
Figure 6. (Left) Loose electrical conduit on Well Back40 (S10). Figure 7. (Right) Sealed electrical conduit on Well Back40 (S10) sent after survey.

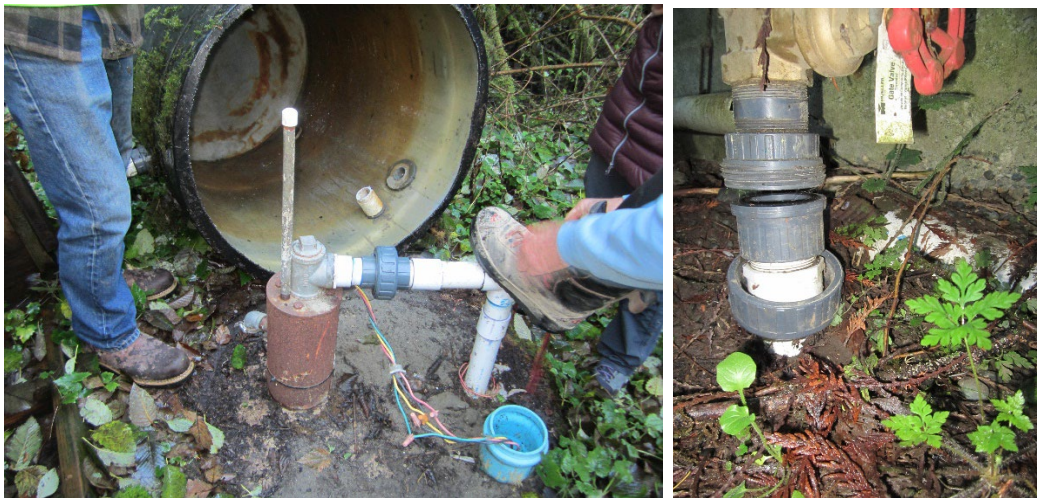
- Canyon Well (AHM851) (S06) –Physically disconnected and considered an emergency source. (Figures 8 and 9). When in use, they blend with the Sand Spring and Driven Wells to reduce arsenic loading to the system.
- Wellfield – Driven Wells 1-9 (S03) includes Wells 1-9 (S05) – Groundwater with hydraulic connection to surface water (Figure 10). (We were unable to access the driven wells during the survey.)
- Sand (S01) – the Sand Spring. Groundwater with hydraulic connection to surface water (Figure 11). (We were unable to access the Sand Spring collection site during the survey.)

Figure 8. (Left). Canyon Well (S06). Figure 9. (Right). Canyon Well is physically disconnected from the system.

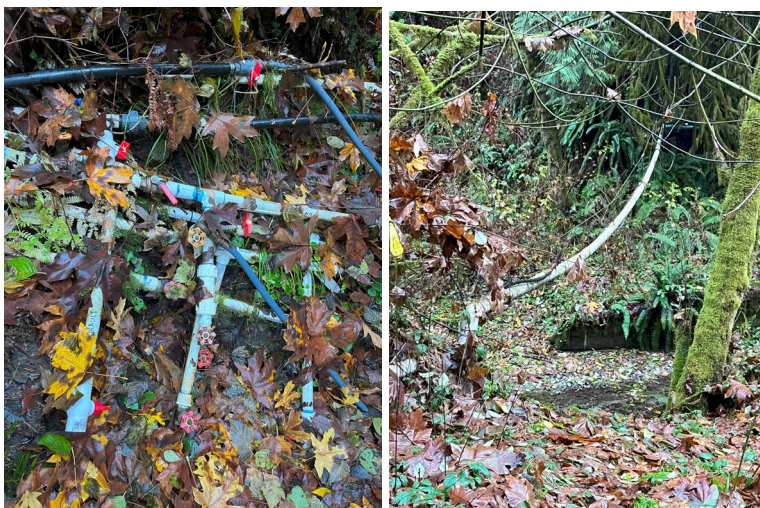
Figure 10. (Left). Wellpoints charging station. Figure 11. (Right) PVC pipe carrying water from springs and wellpoints from across the river.

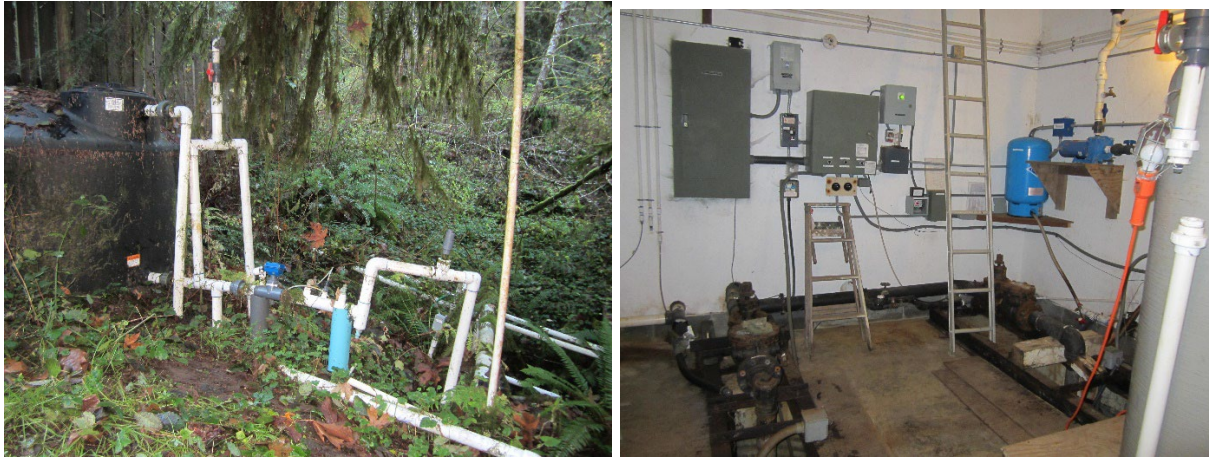
Hypochlorite disinfection provides CT6 with at least 0.5ppm free chlorine residual at entry point to distribution. Treatment Plant Reports show that chlorine residual is being sampled at least five days a week at entry to distribution but is not being sampled at least five days a week at representative points in distribution.

Figure 12. (Left) Springs and wellpoints flow through the 1,100-gallon black collection chamber. Hypochlorite injection is after the overflow and before entering the 15,000-gallon fiberglass holding tank below the Canyon pump house. Figure 13. (Right). Controls inside Canyon pump house.

6. Chlorine residual should be measured at least five days a week at entry to distribution, as well as representative points in distribution per WAC 246-290-451(7).

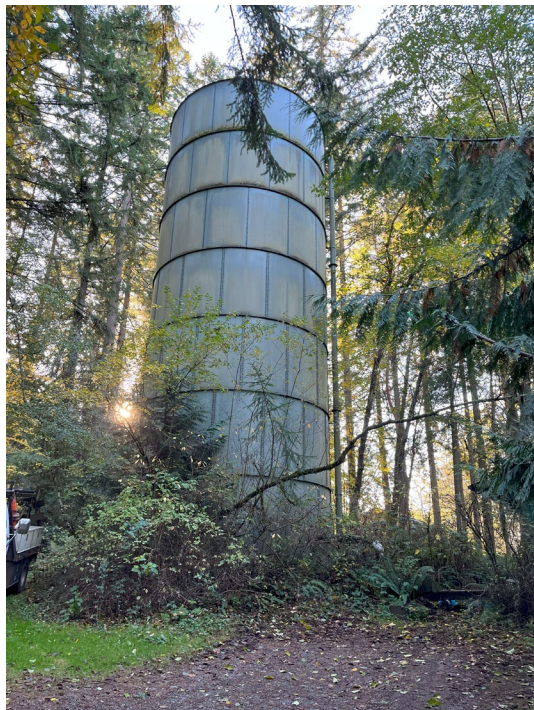
All sources feed the 156,000-gallon steel tank (the Green tank) (Figure 14). The 156th Street BPS pressurizes the system from the Green tank (Figure 15). Entry point samples are collected after the Green tank at the 156th Street BPS (Figure 15).

Figure 14. (Left). Green Tank. Figure 15. (Right) 156th Street BPS and sample tap location.

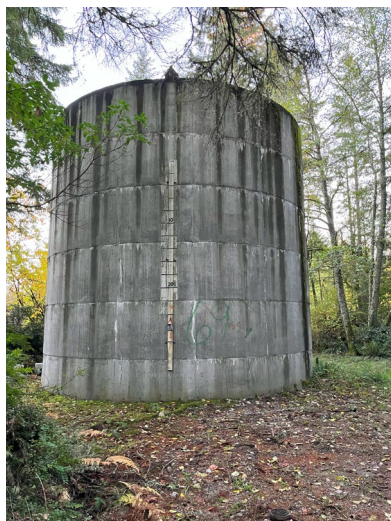
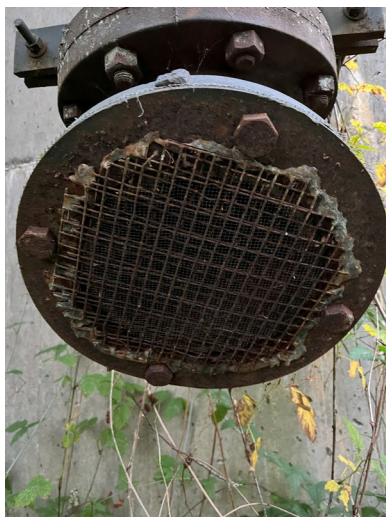
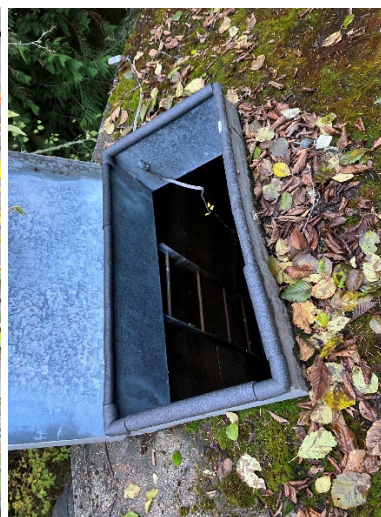
The 156th Street BPS feeds the 100,000-gallon concrete tank (the Cove tank) (Figure 16). The PRV, normally not in use, at the Green tank site allows the Cove tank to serve the system while the Green tank is offline. Cove Tank showed signs of unauthorized access, which puts the drinking water at risk (Figures 18-19).

Figure 16. (Left). Cove Tank. Figure 17. (Middle). Screened overflow pipe. Figure 18. (Right). Hatch and gasket.

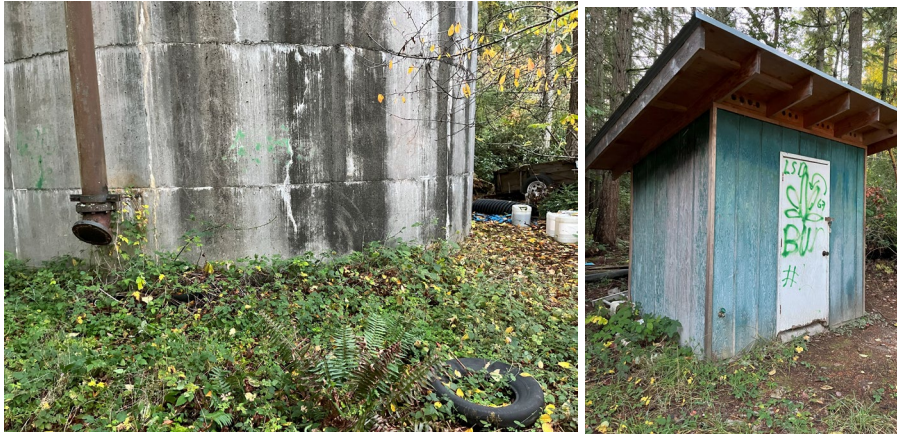
trespassing' signs to deter intrusion. The 2008 photo of the Green tank air vent shows tagging, which is evidence of unauthorized access to the tank. *There are locks on all doors in the system now but consider other methods to keep unauthorized access to Cove Tank.*

Figure 18. (Left). Tires and debris around tank possibly used to access the tank ladder. Figure 19. (Right) Graffiti on Cove tank PS.
